Zener Diode changes on the RLC-1 Board

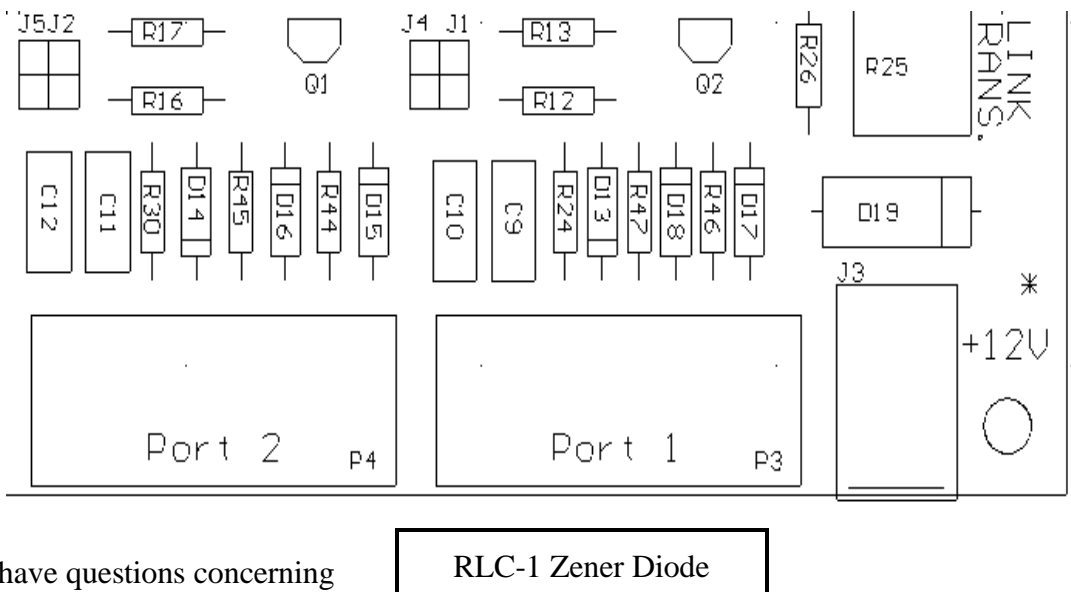
2) Locate zener diodes D15, D16, D17, D18. If you are concerned about removing the diodes from the PC board, simply clip the diodes from the top of the board. Then solder the new diodes to the top of the board where the old diodes were located.

Remember to pay attention to the diodes polarity. The cathode (Side with the bar) should be directed away from the DB-09 connectors. If you have questions concerning this modification, contact Link Communications, Inc.
