RLC-1 Plus Serial Transmit Problem

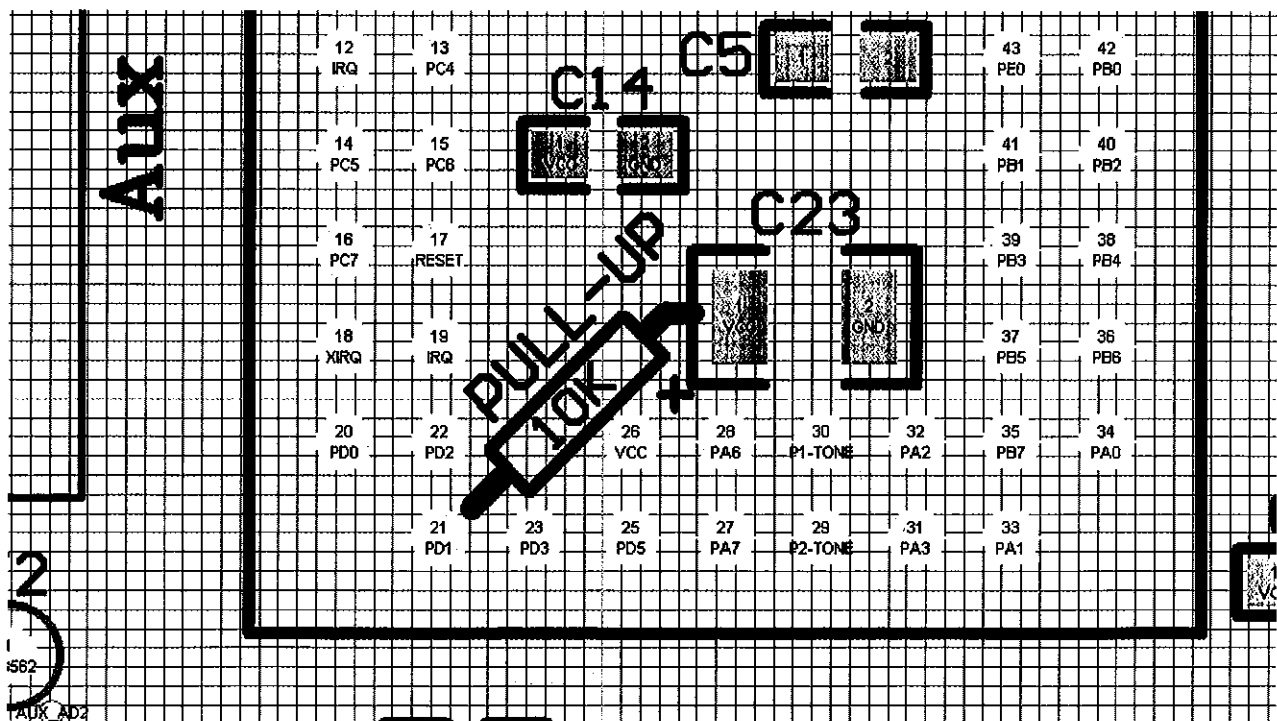
When serially receiving data from the RLC-1 Plus controller, some of the digits are incorrect. The problem is baud rate independent. When sending data to the RLC-1 Plus, no problems are encountered, only when receiving data from the controller.

This problem is caused by a weak pull-up resistor on the serial transmit line. The problem can be addressed by adding a 1/4 watt, 10K resistor between the RLC-1 to RLC-1 Plus board connector, pin 21 and the (+) side of C23. This resistor will provide the needed voltage to overcome the problem.
