RLC-3 Port Card not responding Modification

This modification is needed if a port card will not respond. This is most notable on ports above Port 5. The modification requires that a trace is cut and it is then buffered through a clock buffer circuit. The buffer circuit is U8.

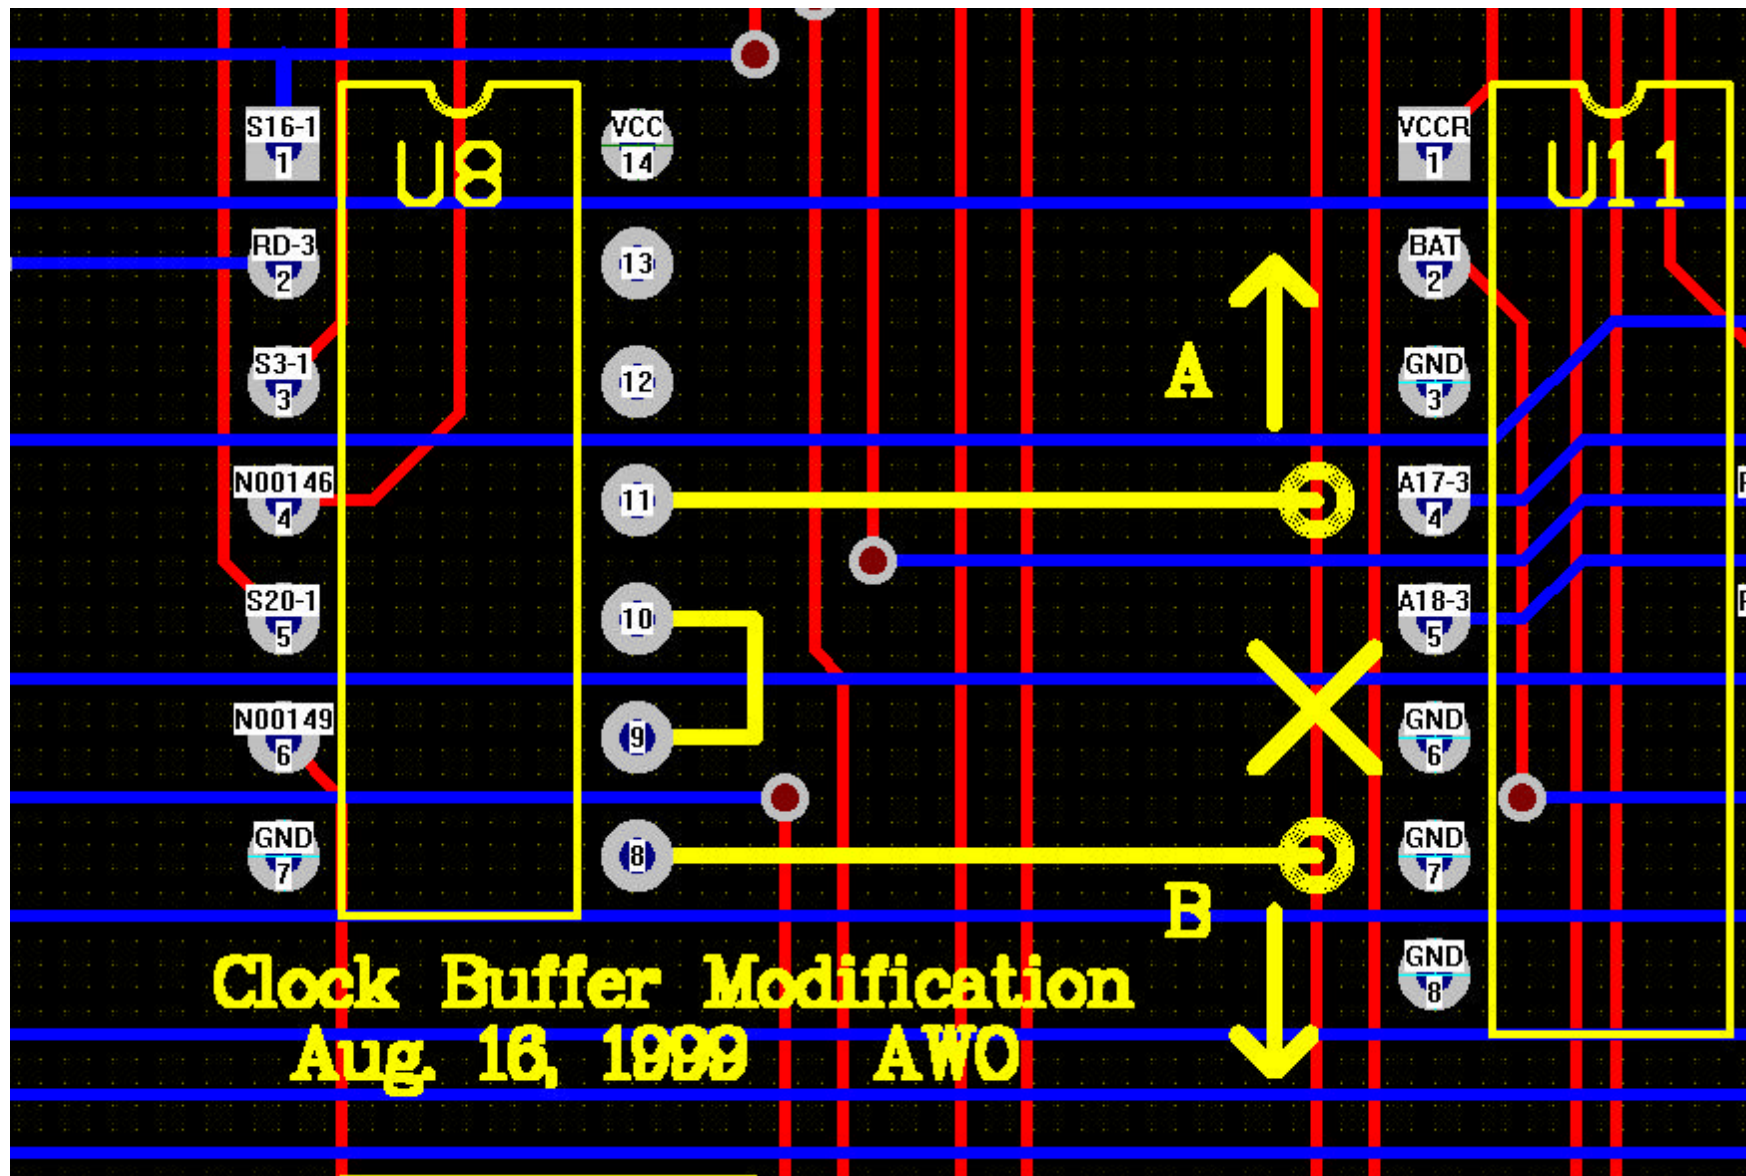
1) Locate the drawing RLC3_1.PDF

This file shows the location of the trace modification and the buffer circuit.

- Cut the trace indicated
- Connect pin 11 of U8 to location 'A'
- Connect pin 8 of U8 to location 'B'
- Connect pins 9,10 together

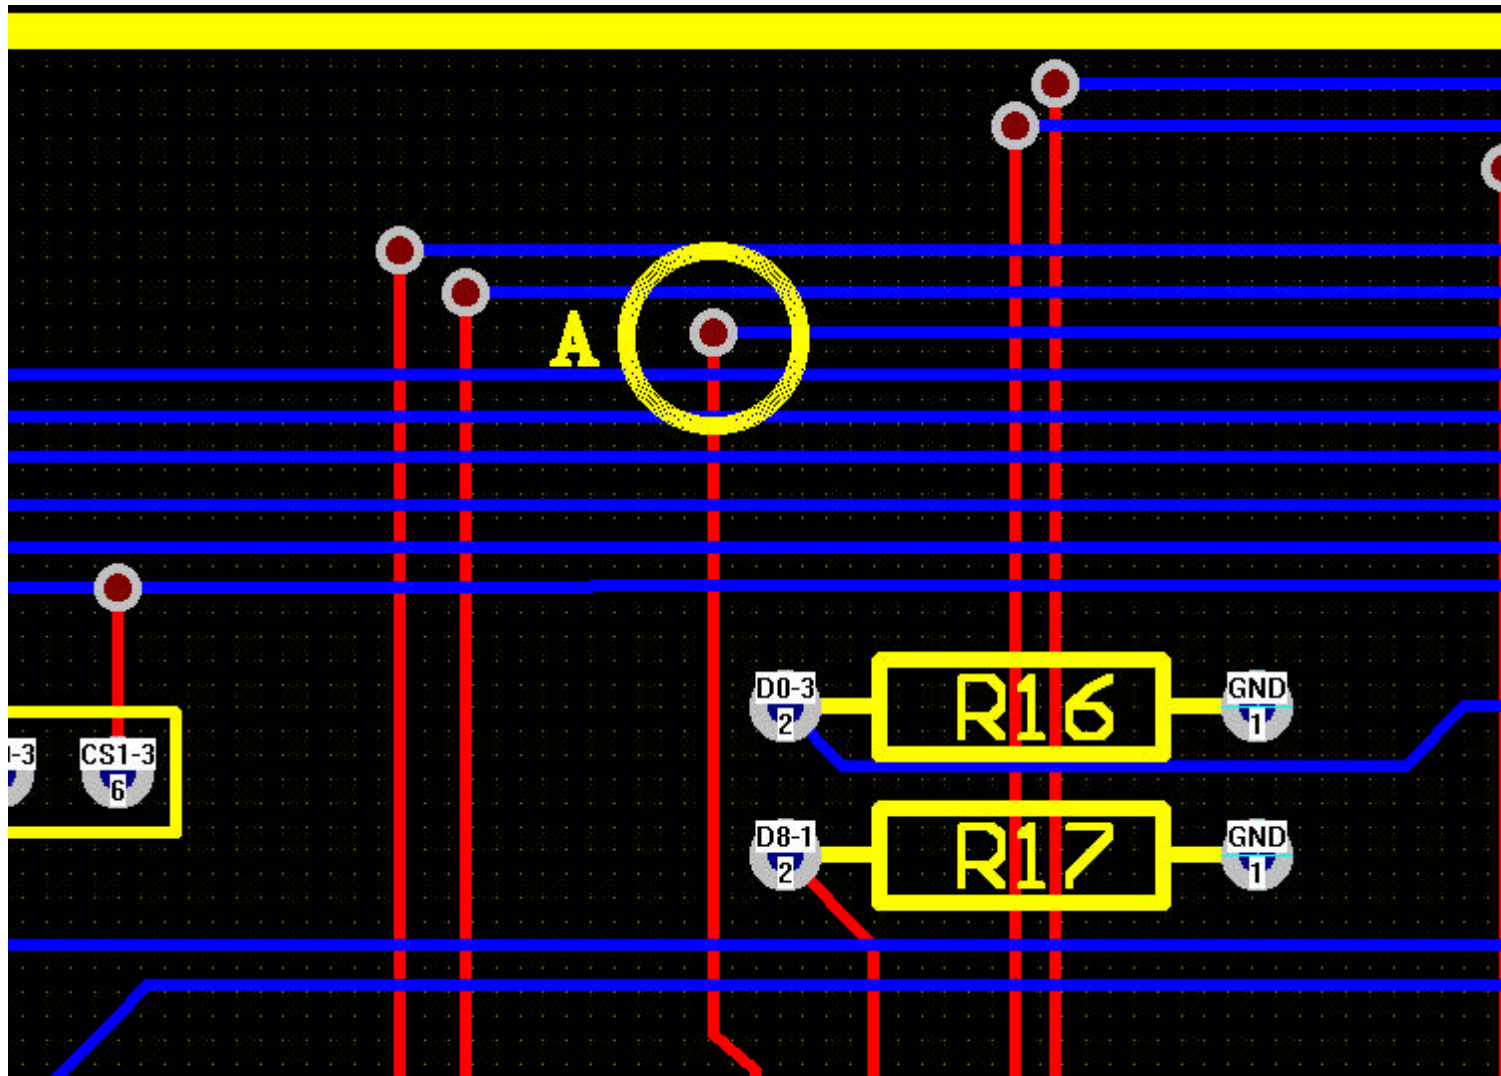
2) Locate the drawing RLC3_A.PDF

This file shows the location of the 'A' connection point

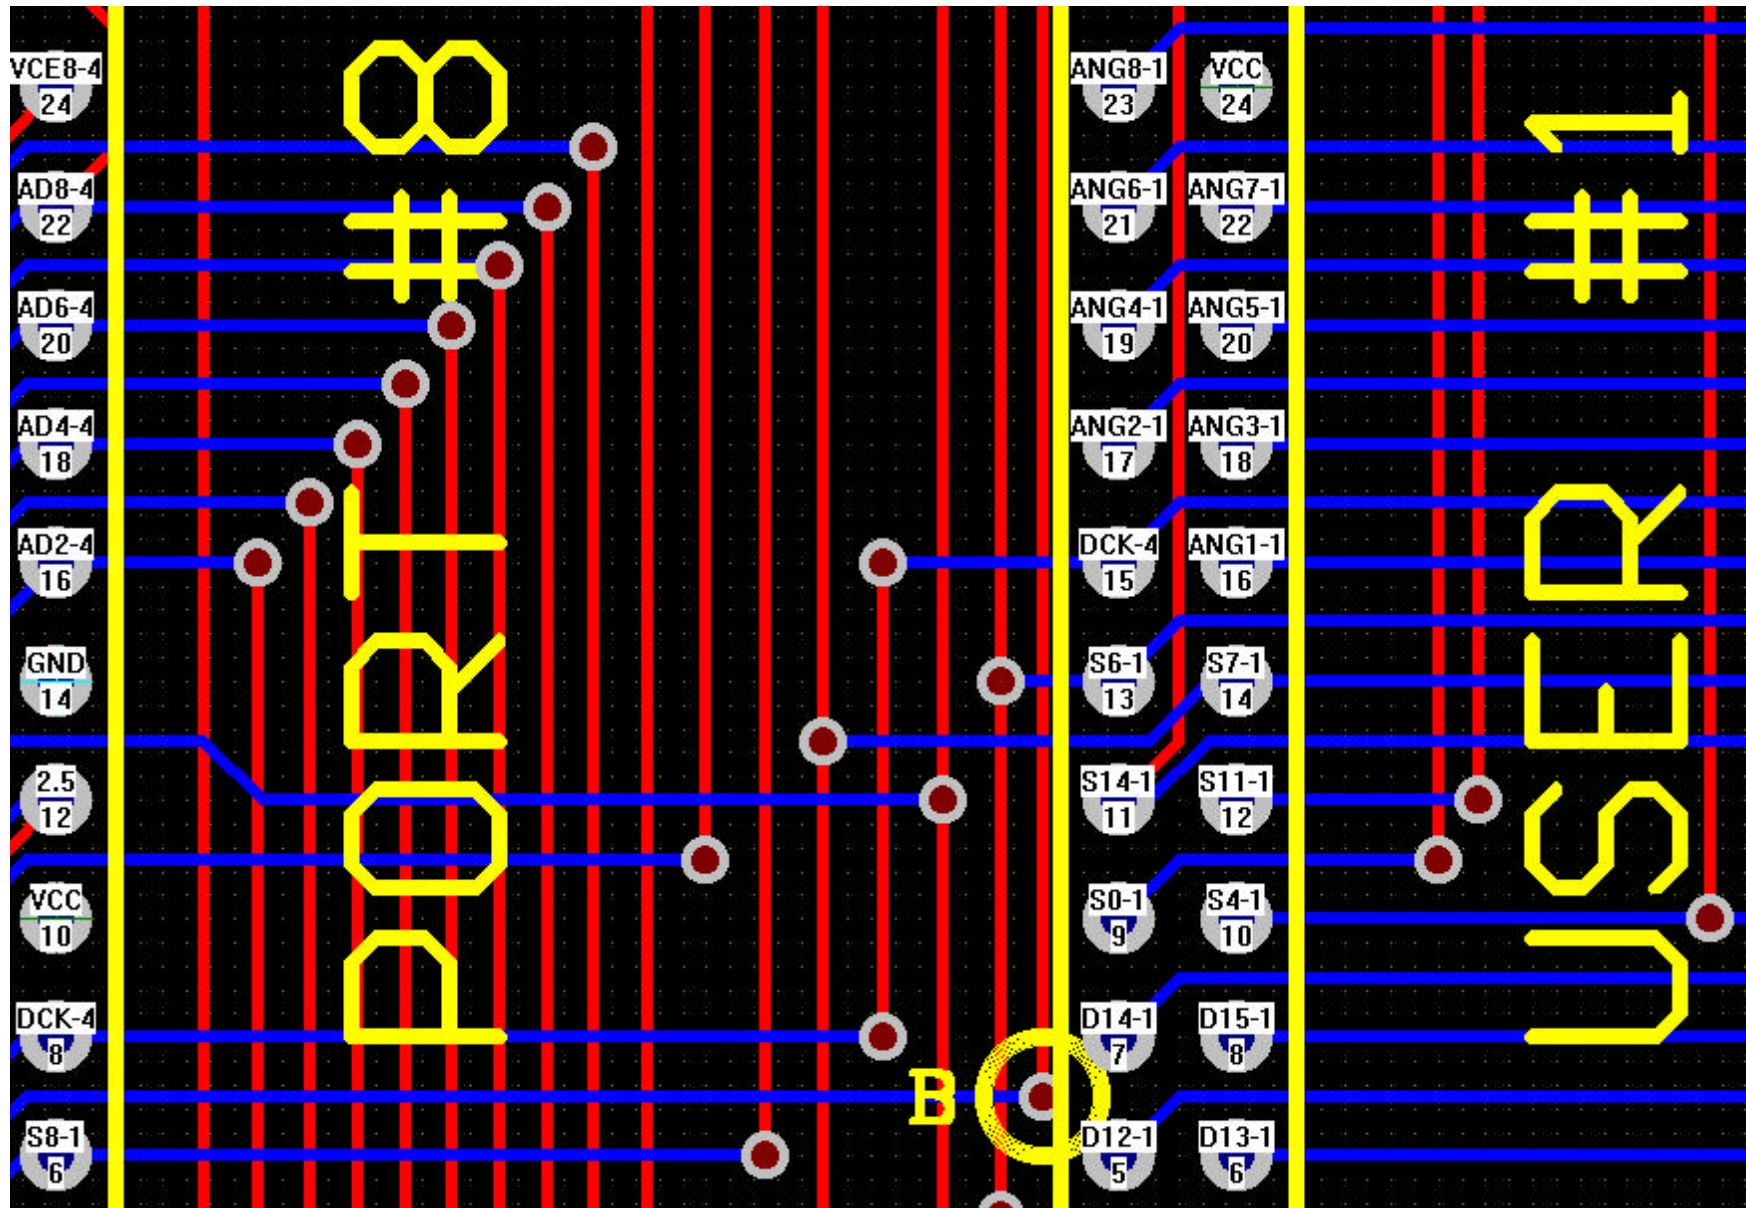
3) Locate the drawing RLC3_B.PDF

This file shows the location of the 'B' connection point
